**WINNICUT DAM REMOVAL
FEASIBILITY STUDY**

**HYDRAULIC
FISH PASSAGE
AND ALTERNATIVES ANALYSIS**

By
John E. Richardson, Ph.D., P.E.

February 2004

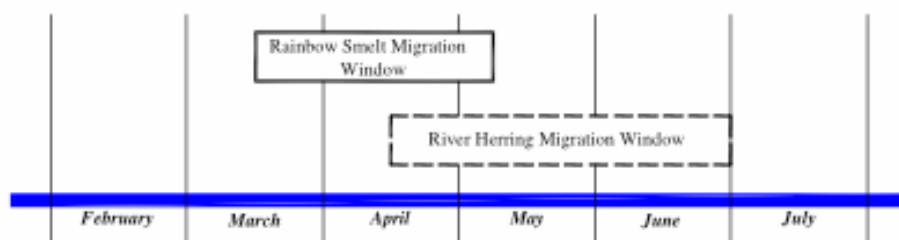
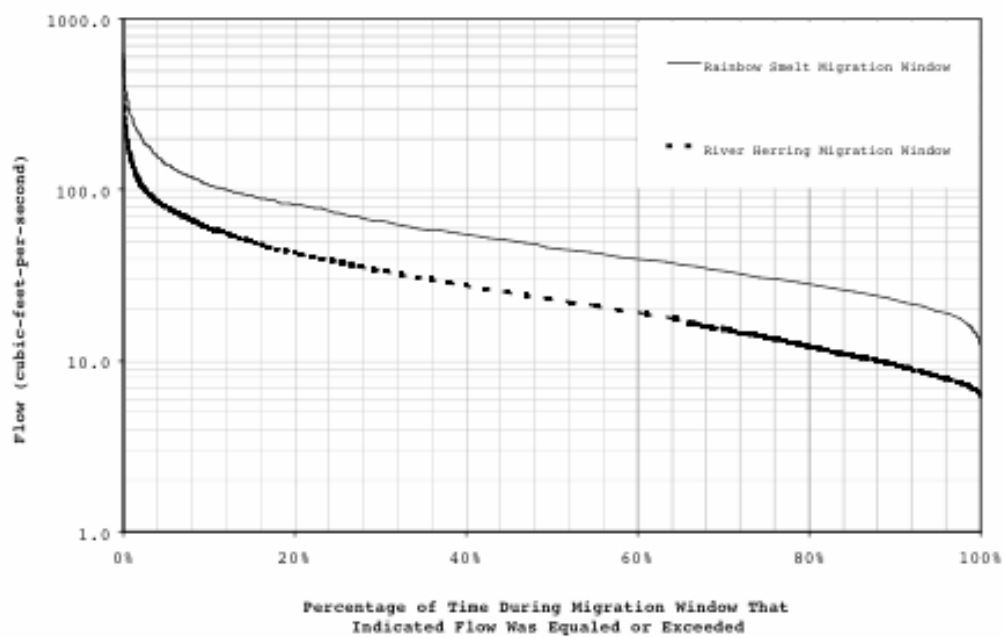
Figure 1: Flow-Duration Curves
(Courtesy of Woodlot Alternatives, Inc.)

Spawning Migration Windows

Estimated Flow-Duration Curves During Target Fish Migration Periods

Three different, preliminary simulations were performed in September 2003. In each of these simulations the flow rate under the Route 33 Bridge was set equal to 40 cfs. This is a typical flow rate associated with the spring migration period for River Herring and Rainbow Smelt (two of the target fish species at this site, see Figure 1).

A review of hydrologic data was performed and flow duration curves (Figure 1) for the Winnicut were developed. River flow rates expected to occur during periods of migration were identified and corresponding water surface elevations were estimated. Boundary conditions for the numerical simulations were developed from these data.

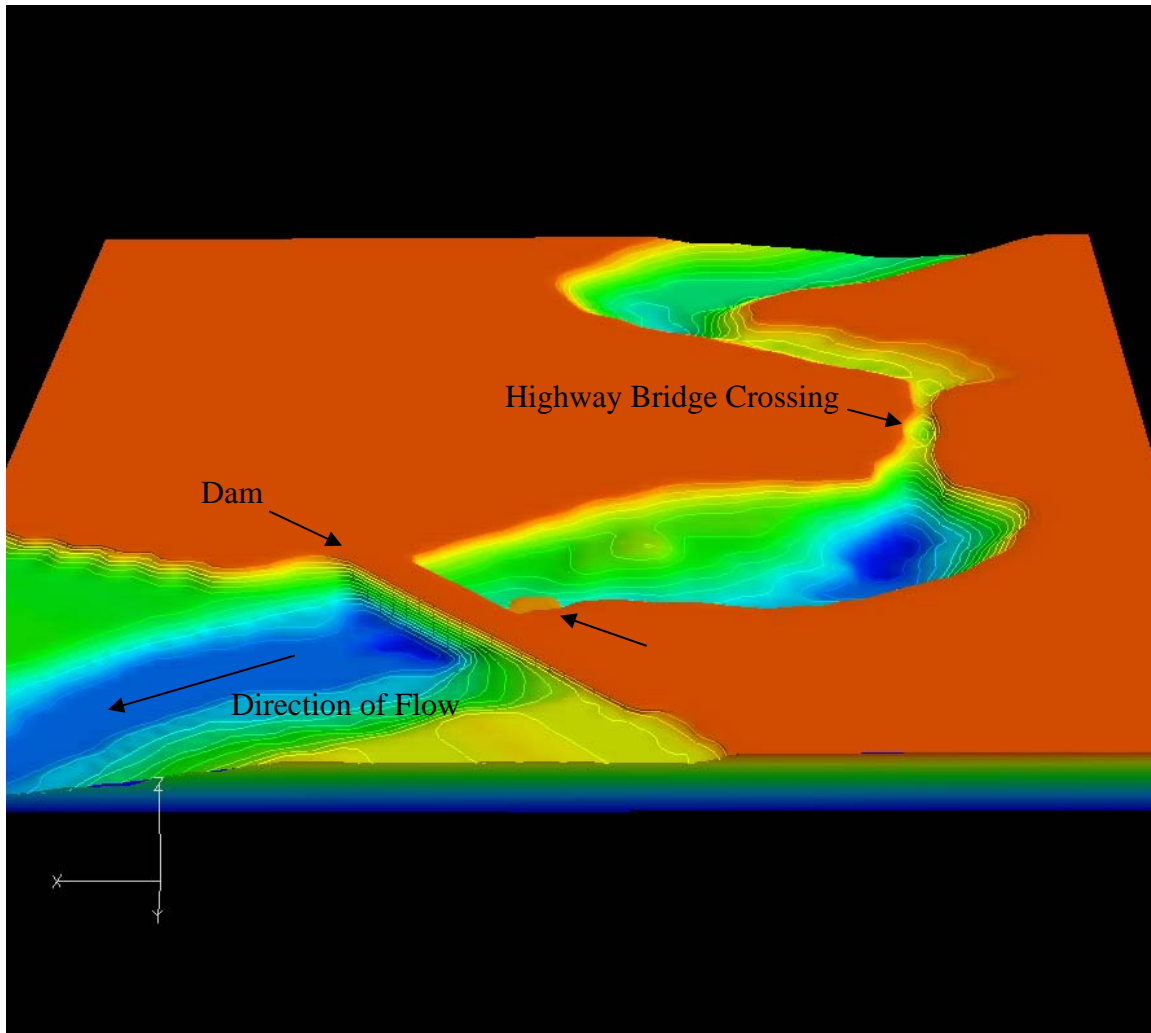
Figure 2: Model Domain, Dam In Geometry
(oblique view, colored by elevation)

Present day conditions were modeled first, to establish a baseline for comparison with other fish passage options. Figure 2 shows a layout of the model domain. The terrain in the figure is colored by elevation. The deepest areas in the river are colored blue and dry

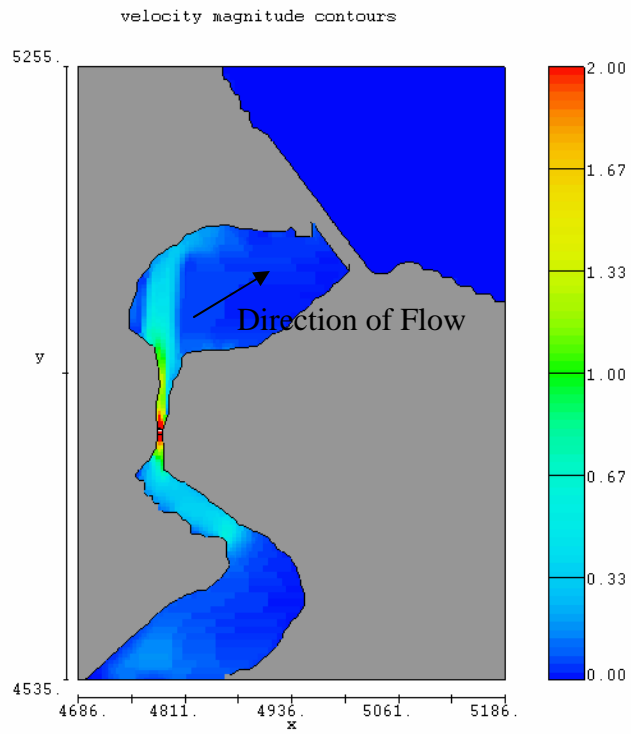
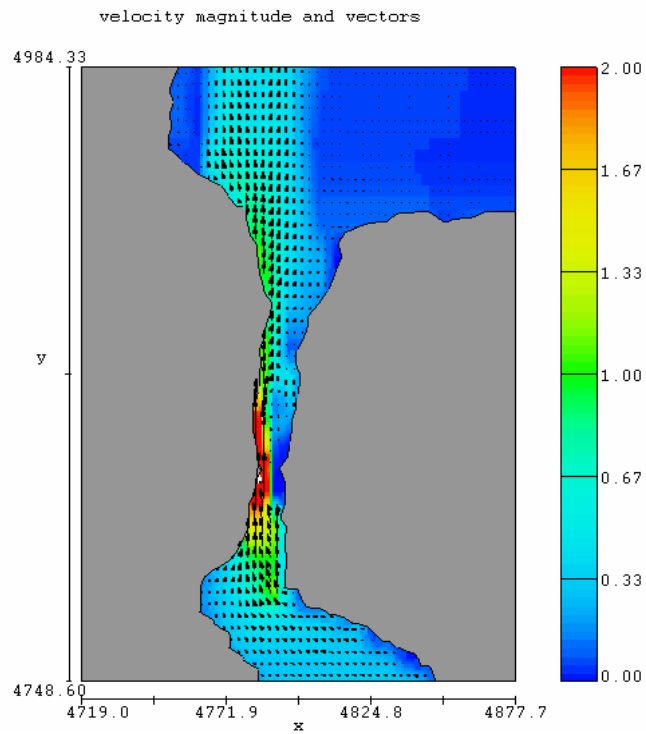
Figure 4: Calculated Flow Patterns

Figure 4 shows computed velocity distributions in the river channel beneath the Route 33 Bridge. For 40 cfs, with the dam in place, typical channel velocities were calculated to be less than 2.0 ft/sec at most locations; however, and at one location maximum velocities were calculated to be 5.8 ft/sec. According to this analysis, upstream fish passage should be expected beneath the bridge with the dam in place. Although, some changes to shape of the channel are recommended to eliminate the area of high velocity.

(a) Global Solution, (b) Local Solution – max. speed is 5.8 ft/s
(colored by speed, engineering units, speeds greater than 2.0 ft/s are red)

Flow approaching the Winnicut Dam was calculated with 40 cfs for present day conditions. Results of this analysis predict a localized area of high velocity (5.8 ft/s) in the stream beneath the existing roadway bridge. Calculated velocities in the pool upstream of the Dam are low (less than 1 ft/s).

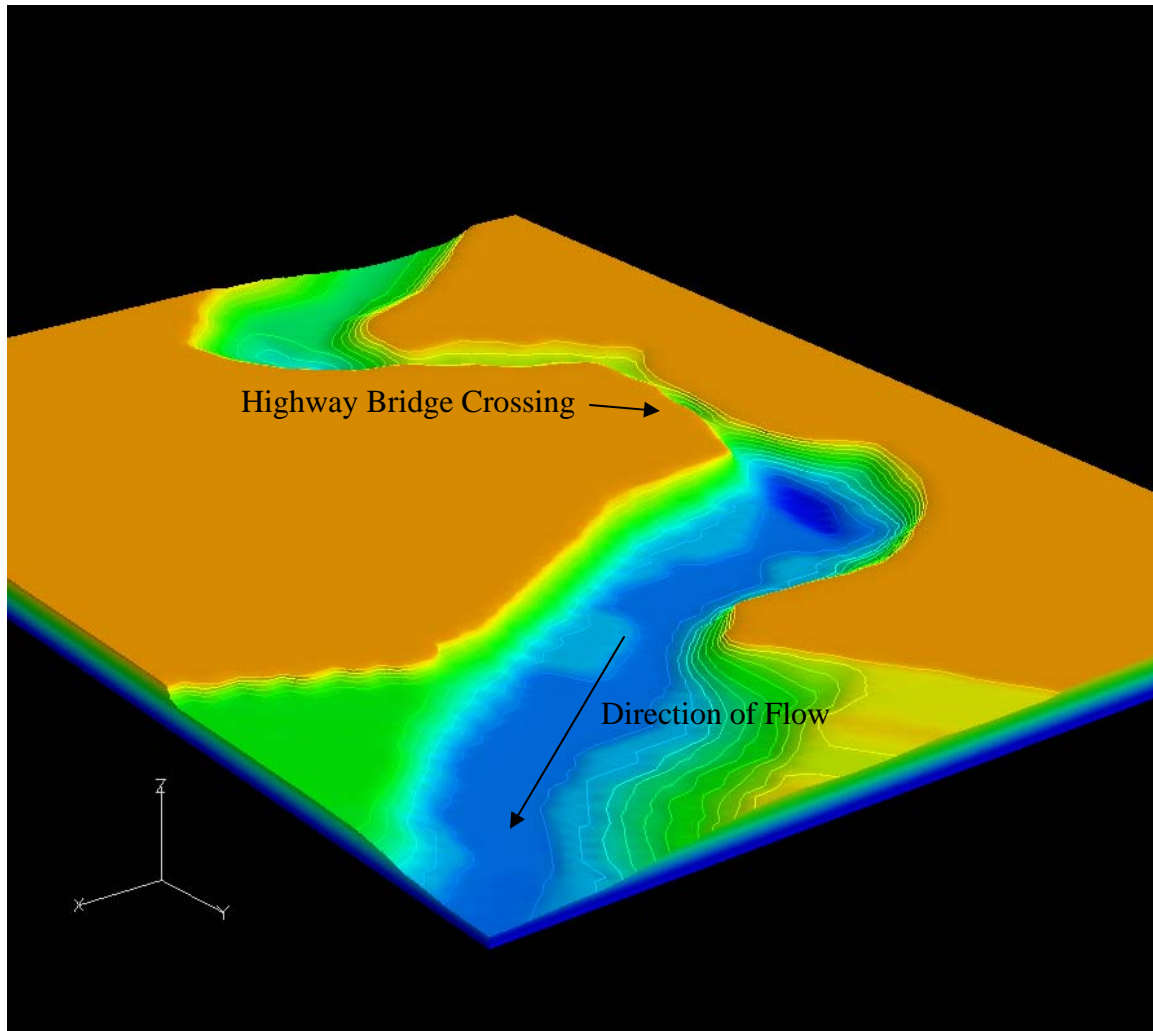
Figure 5: Model Domain, Dam Out Geometry
(oblique view, colored by elevation)

Hydraulic conditions associated with a dam-out condition were compared to the results of the present day simulation. Figure 5 shows a layout of the dam-out model domain. The terrain in the figure is colored by elevation. The deepest areas in the river are colored blue and dry areas are red. Figure 6 shows the same data, only the viewpoint has been changed to provide a plan view of the model domain. Similar to Figure 3, the constriction in the river caused by the bridge crossing is plainly seen in Figure 6.

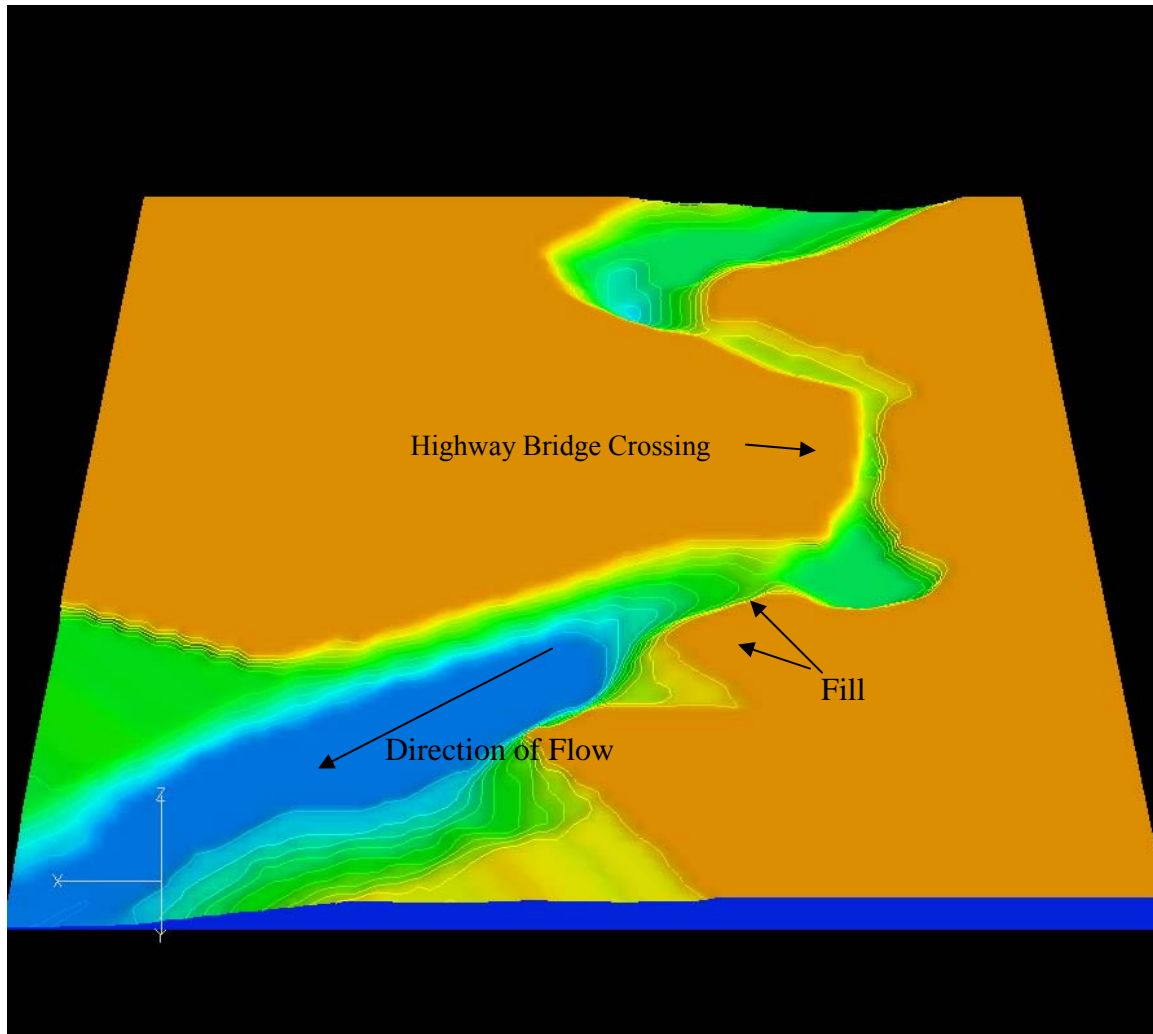
Figure 10: Model Domain, Fish Passage Geometry
(oblique view, colored by elevation)

Hydraulic conditions associated with replacement of the dam with a technical fish passage were calculated. Figure 10 shows a layout of the model domain. The terrain in the figure is colored by elevation. The deepest areas in the river are colored blue and dry areas are red. Figure 11 shows a close up of the technical fish passage.

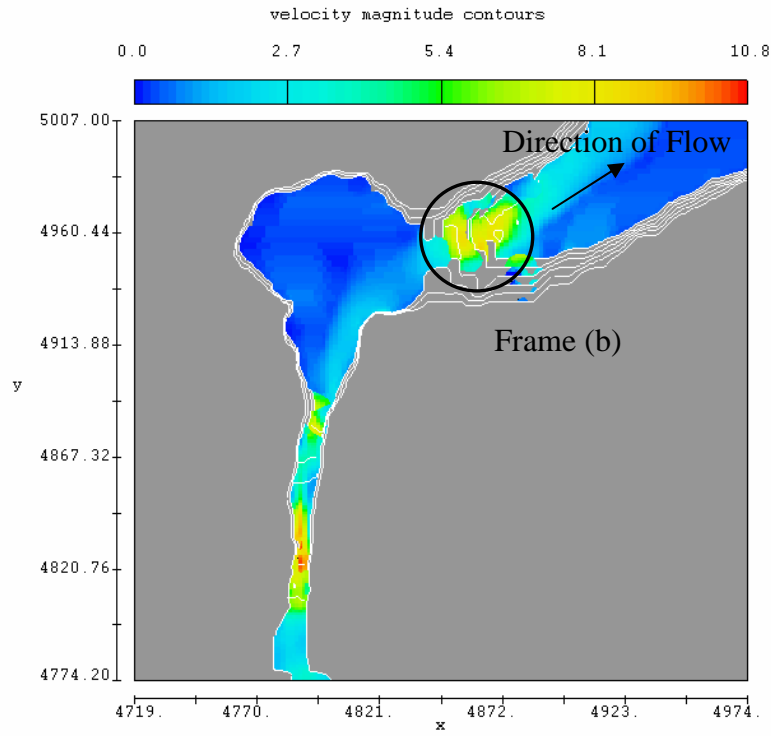
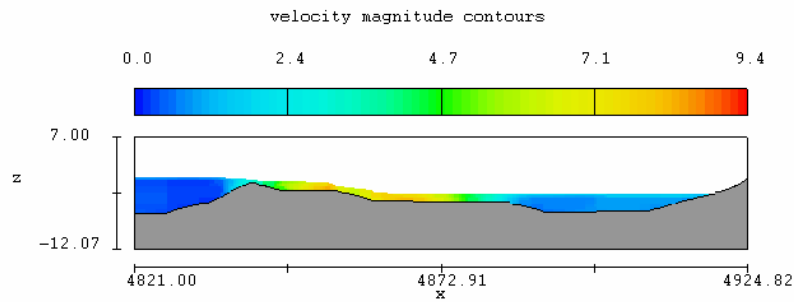
Figure 12 shows computed velocity distributions in the river channel beneath the Route 33 Bridge and through the technical fish passage. For 40 cfs, typical channel velocities are calculated to be around 6.0 ft/sec and maximum local velocities were calculated to be as high as 9.4 ft/sec. According to this analysis, reliable upstream passage of fish would not be possible if this design approach were pursued (in this proposed configuration). However, additional fill could be used to enlarge the technical fish passage; to effectively raise its crest elevation and moderate its slope. These changes would reduce velocities in the channel beneath the Route 33 Bridge and in the technical fish passage. The primary drawback of this design approach is the amount of fill that would be required to construct a technical fish passage at this location.

Figure 12: Calculated Flow Patterns
(a) Global Solution, (b) Technical Fish Passage – max. speed 9.4 ft/s

Notes: (a) “Drop-outs” in graphics appear when the computed flows are quite shallow (*i.e.*, when control volumes are less than half full). There is no loss in accuracy associated with the drop-outs and the results do not represent a discontinuous flow (the drop-outs are a feature of the graphics program only). (b) Different color scales were used in each of the frames to better illustrate the range of velocities calculated for this flow condition.

In a third calculation, a technical fish passage replaced the Winnicut Dam. The passage is a conceptual design intended to bring fish upstream to an elevation similar to that of the river channel invert beneath the bridge. The proposed technical fish passage also provides a resting pool for migrating fish and protects the bridge abutments from scour.

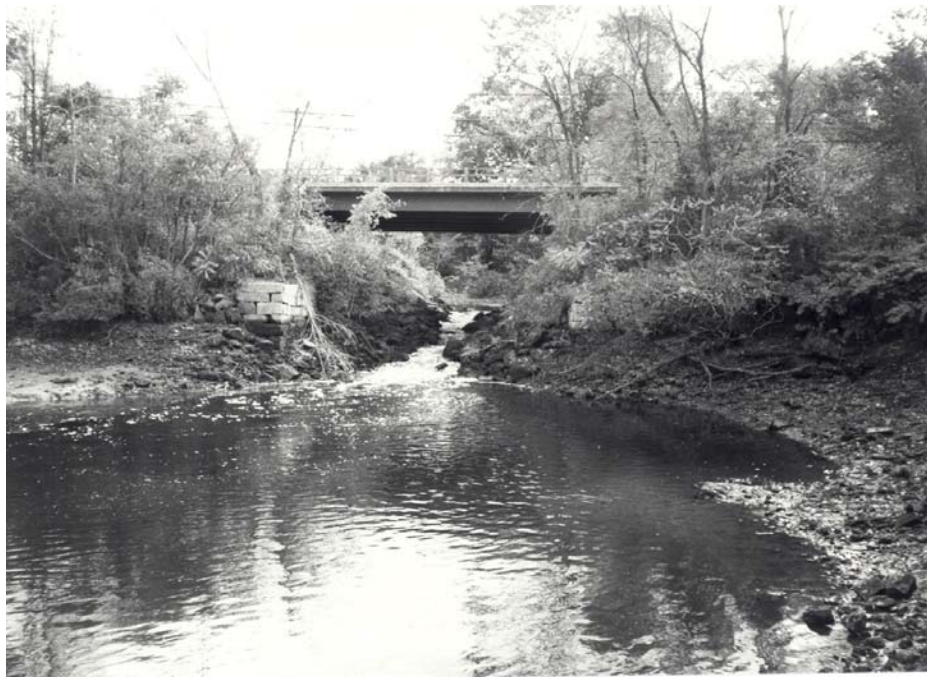
Figure 14: Flow beneath Route 33 Bridge (Drawdown – 10/17/03)

Flow in the channel beneath the Route 33 Bridge was calculated for a 10 cfs condition. Results of this analysis agree with field data collected during the drawdown (10/17/03) and suggest that areas of high flow speed would develop in the channel if the dam were removed. Fish passage through these areas of high velocity may not be possible and some changes to the channel design will be required in the event that the Winnicut Dam is removed and the channel beneath the bridge is used for fish passage.

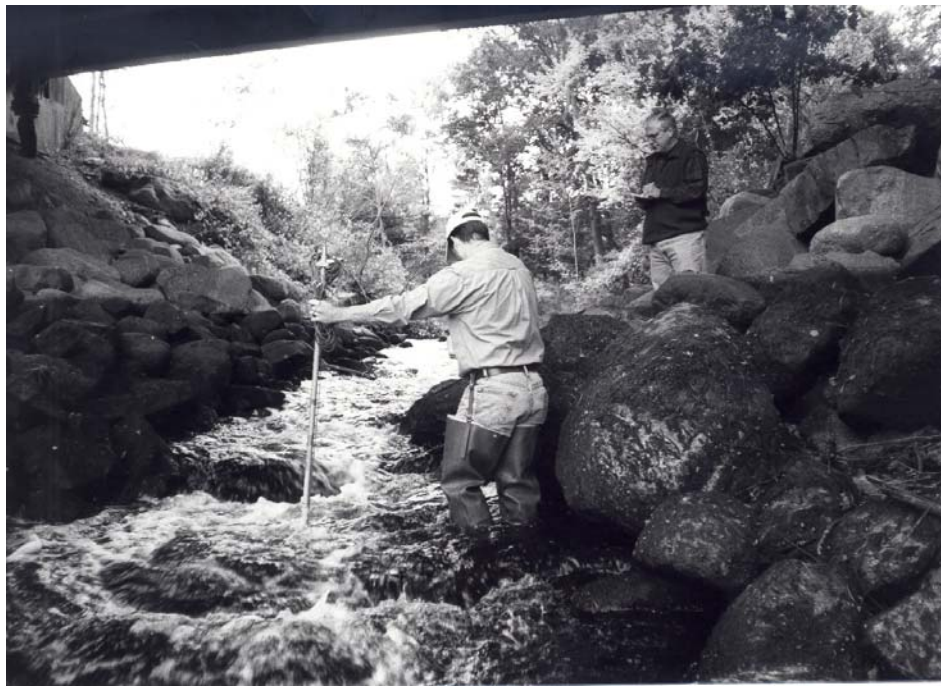
Figure 15: Flow Measurement beneath the Route 33 Bridge
(Drawdown – 10/17/03)

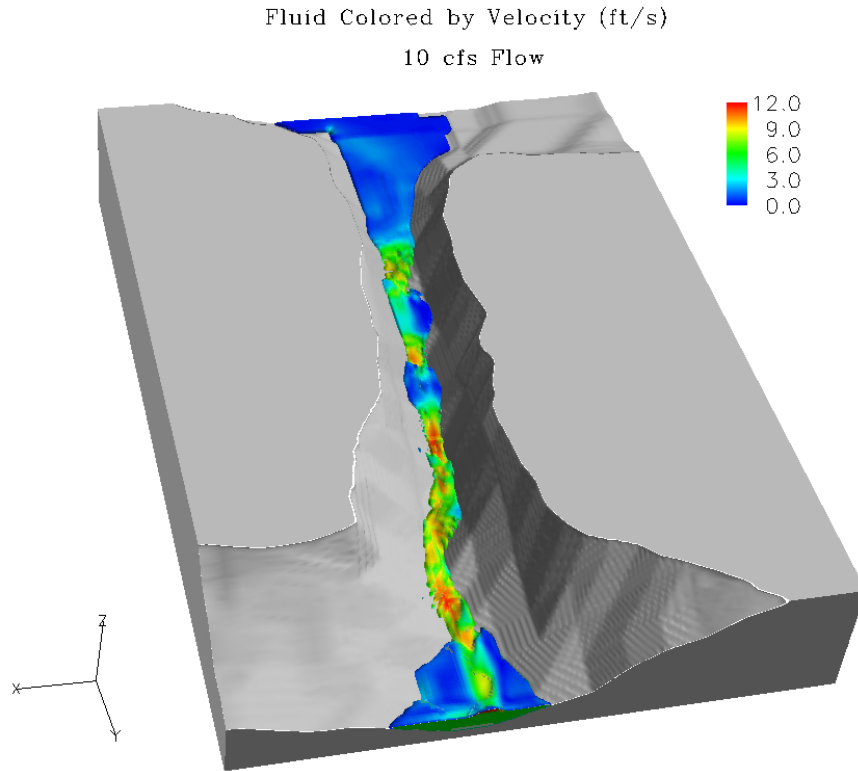
Figure 17: Calculated Flow beneath the Route 33 Bridge (10 cfs)

Simulations of flow beneath the Route 33 Bridge were carried out for a 10 cfs condition (Figure 17) and the results were compared to velocity measurements made during the Winnicut Dam drawdown (Figure 16). In general, the comparison is close. However, some localized areas of high velocity (*e.g.*, 12 ft/sec) that are predicted by the numerical model do not appear in the field measurements. These discrepancies arise from the fact that the geometry of the numerical model is slightly different than the geometry of the natural channel and the fact that the velocity measurements were not necessarily made in the locations of highest velocity (*i.e.*, the discretization of the field sampling program was different from the discretization of the numerical model). Nevertheless, the results of both studies indicate a gradual increase in velocities as the water moves down the channel leading to the development of entrance conditions that could be difficult for fish to negotiate when moving upstream (*i.e.*, fast & shallow flow, see Figure 18).

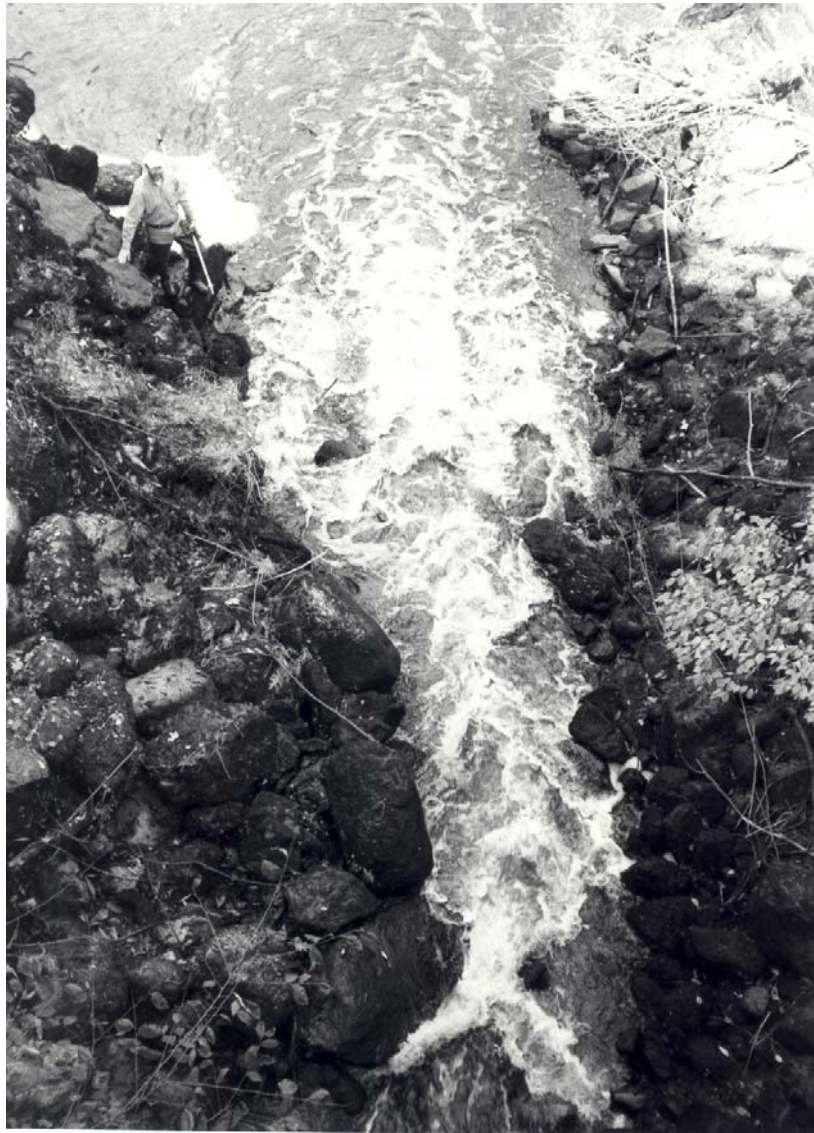
Figure 18: Flow beneath the Route 33 Bridge
(10 cfs, the direction of flow is towards the top of the page)

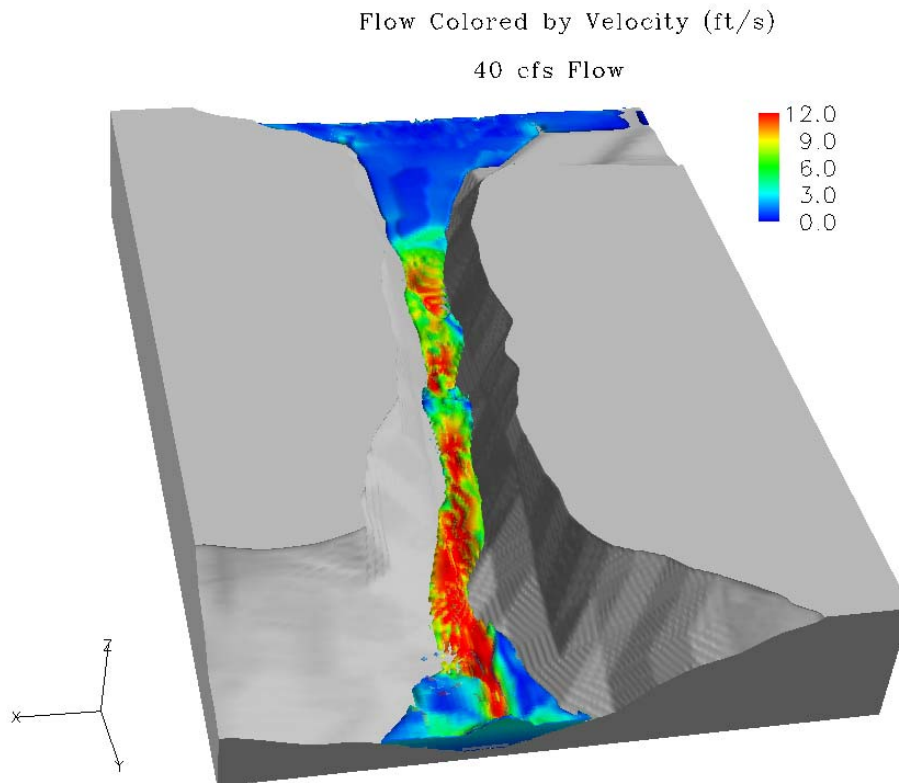
Simulations of flow beneath the Route 33 Bridge were carried out for a 40 cfs condition (Figure 19) and the results were compared to swim speed data. For a 40 cfs condition, velocities in significant portions of the channel beneath the Route 33 Bridge are calculated to exceed 10 ft/sec (**note:** these are better estimates of flow speeds compared to those produced by the preliminary analyses since they benefit from the calibration with field data, and other improvements made to the formulation of the simulation model). In order to provide reliable fish passage during periods of 40 cfs flow it will be necessary to re-configure the shape of the channel to reduce maximum flow speeds in the channel. Hand-calculations suggest that the channel slope should be reduced from 1:20 to about 1:24 to facilitate this change.

Figure 19: Calculated Flow Beneath the Route 33 Bridge (40 cfs)

In a second calculation, flows were increased to 40 cfs (a typical flow rate occurring during times of migration) and flow speeds in excess of 10 ft/sec were predicted throughout the channel.

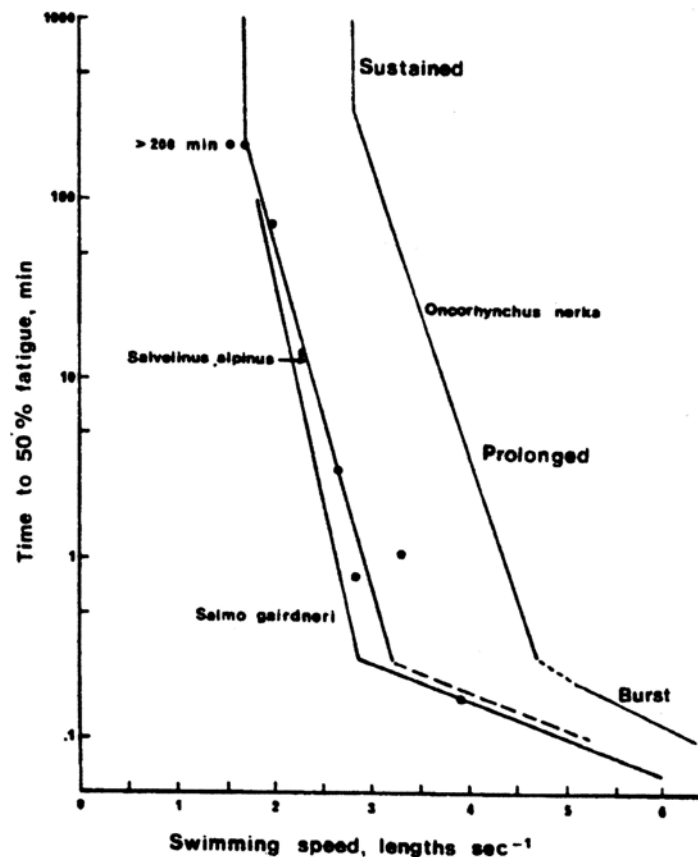
Fish swimming can be classified into three categories: *sustained*, *prolonged*, and *burst swimming* (Beamish 1978). Examples are shown in Figure 20. Sustained swimming is that which can be maintained indefinitely (i.e. longer than 200 minutes); it is also referred to as cruising speed. Prolonged swimming is a moderate speed that can be maintained for a specific period of time (i.e. up to 200 minutes). Burst swimming is the fastest speed achievable and can only be maintained for short durations as it utilizes more anaerobic metabolism than the other swimming modes. Another measurement of fish swimming ability commonly reported in the literature is U_{crit} , (critical swimming speed), which is a standardized calculation of the maximum swimming speed a fish can maintain for a predetermined period of time. As these times are typically between 10 and 200 minutes, U_{crit} falls under the category of prolonged swimming speed.

Figure 20: Examples of sustained, prolonged, and burst swimming for three salmonid species shown in terms of time to fatigue. From Beamish (1980) as cited in EPRI (2000)

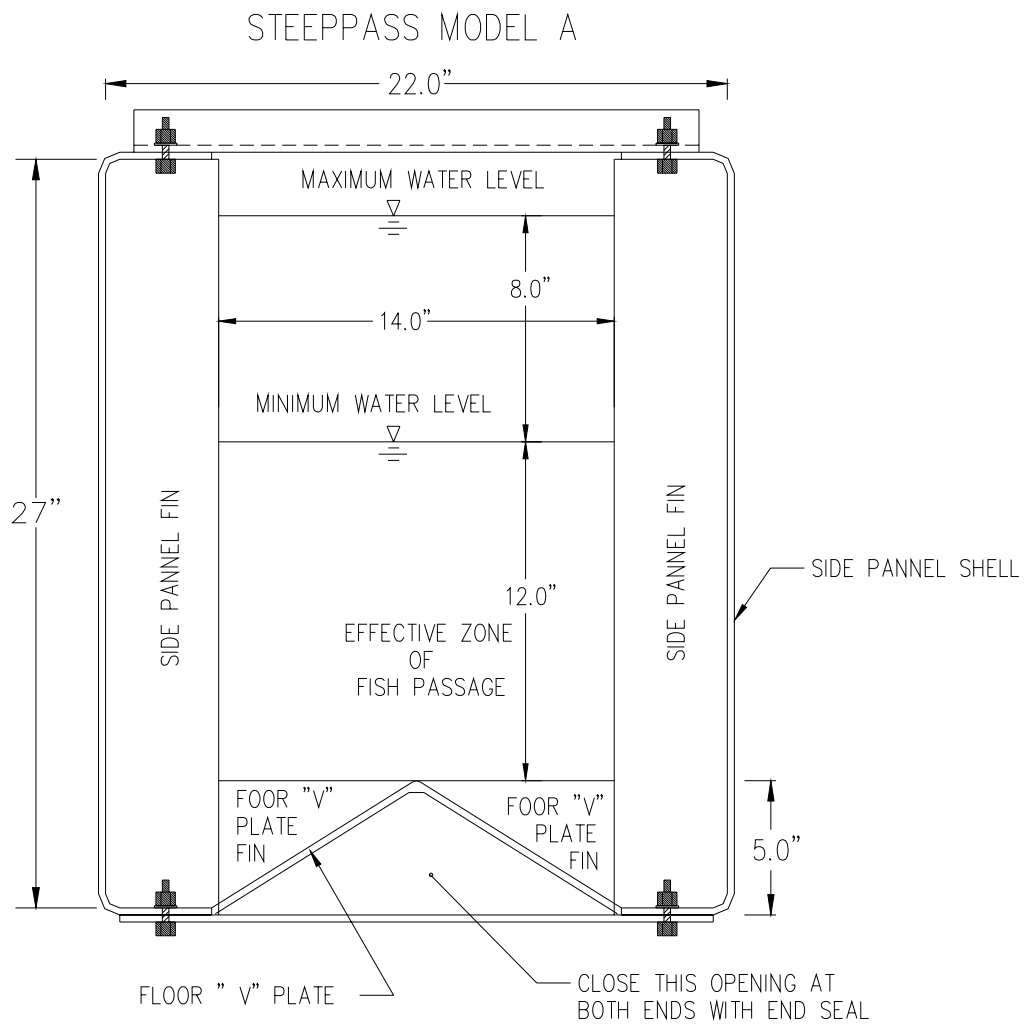
Figure 23: Steeppass Model A Cross-Section

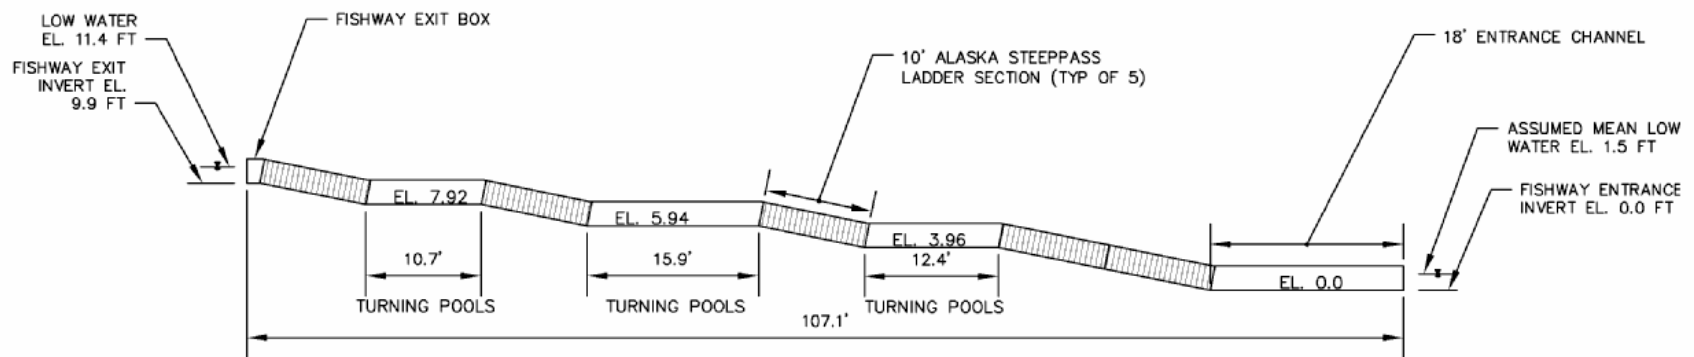
ALASKA STEEPPASS FISHWAY CENTERLINE PROFILE
